Monitoring Cruise at the  
Massachusetts Bay Disposal Site  
March 31 - April 4, 1992

# Disposal Area Monitoring System DAMOS

Contribution 100  
October 1995

Report No.  
SAIC-C103

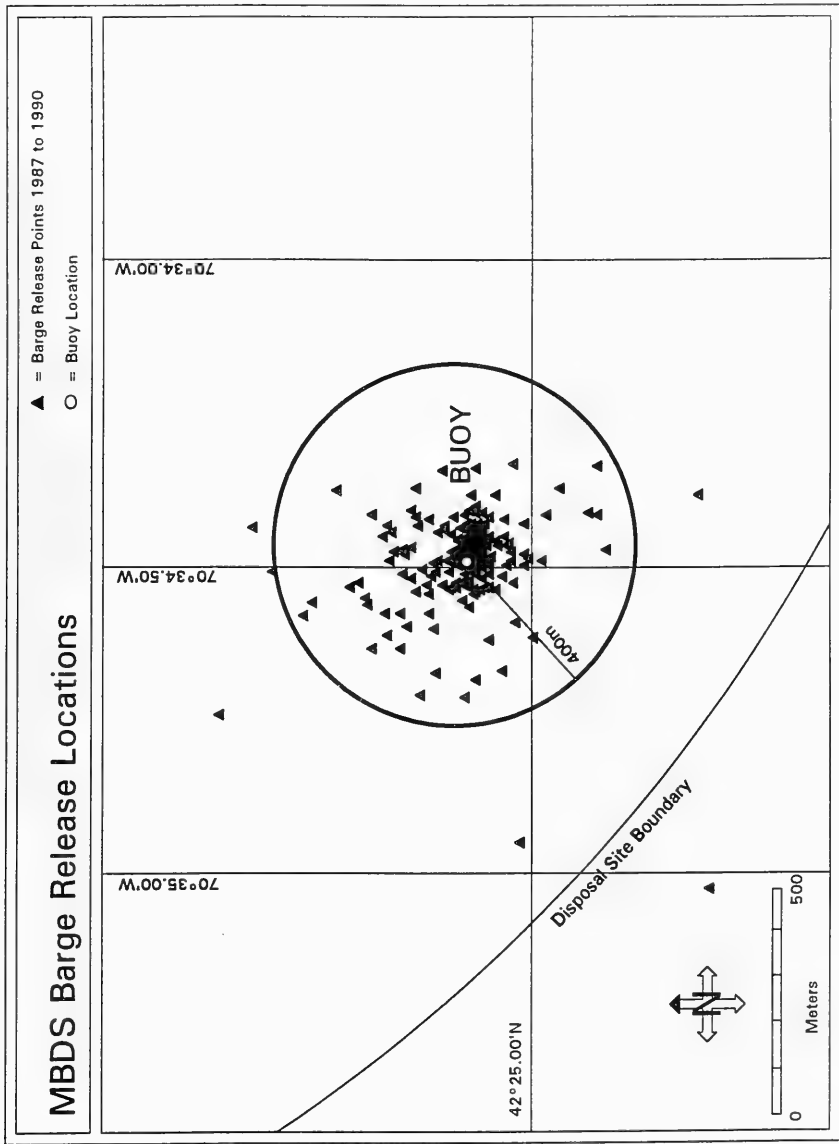
Figure 4-3. Barge release locations for the 1988-1990 disposal season
